REPORT OF PHASE I ENVIRONMENTAL SITE ASSESSMENT

BALDWIN HARDWARE MANUFACTURING CORPORATION 841 EAST WYOMISSING BOULEVARD READING, PENNSYLVANIA

August 27, 2003

LOUREIRO ENGINEERING ASSOCIATES, INC. 100 Northwest Drive Plainville, Connecticut

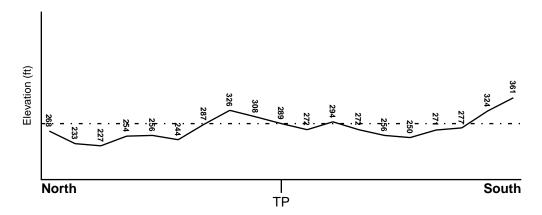
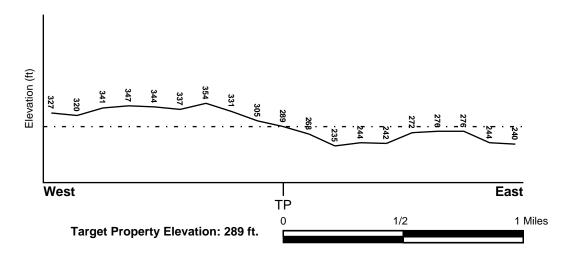
SURROUNDING TOPOGRAPHY: ELEVATION PROFILES

Source: Topography has been determined from the USGS 7.5' Digital Elevation Model and should be evaluated on a relative (not an absolute) basis. Relative elevation information between sites of close proximity should be field verified.
